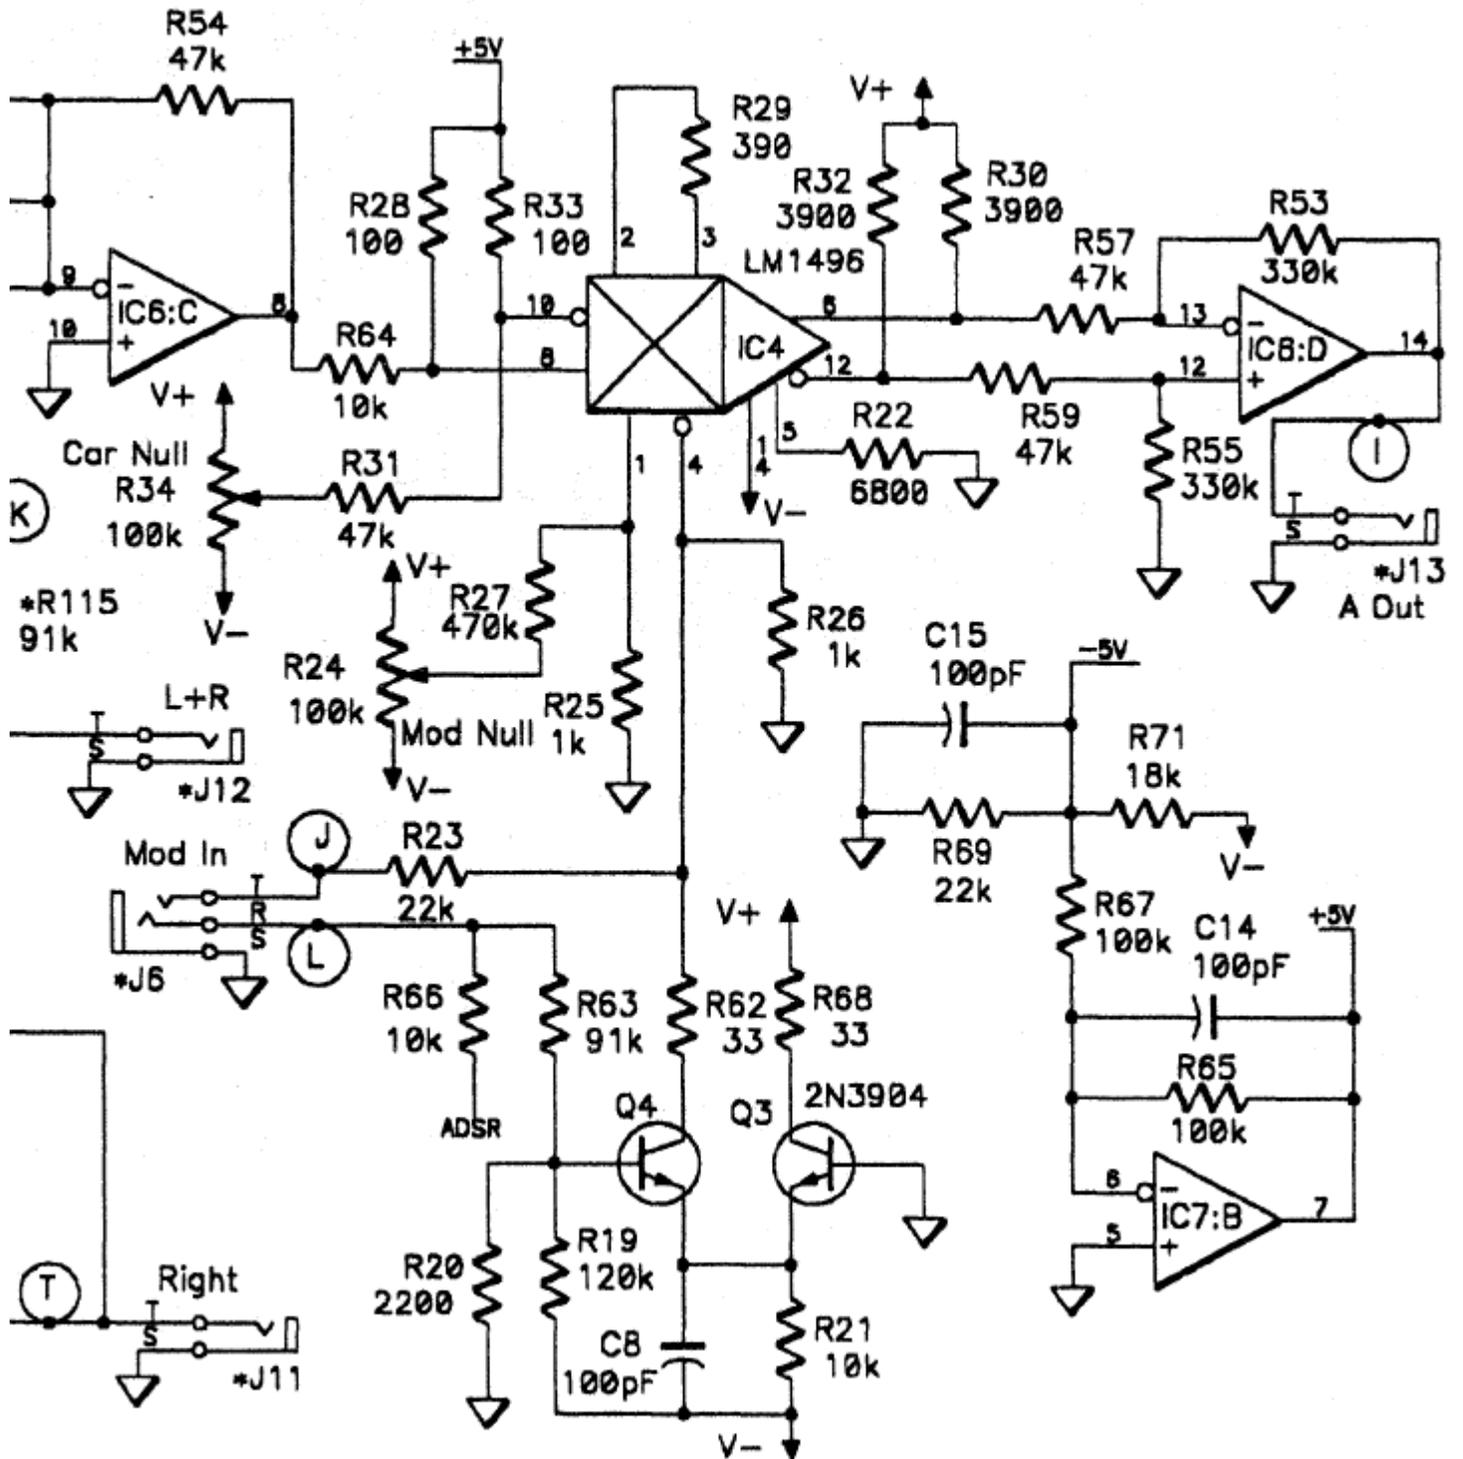
VCA section from 9710 illustration supplement, fig 7, schematic

“In step #4 there was a slight tone with the Pan control at full "R"; when turning the "Modulation Null Trimmer" there was no discernible difference in the tone.

In step #6 there was a modulation sound, but the carriers were not of the same volume. The original carrier was much more dominant than the modulating signal.

Specific to the trouble you describe, the R24 Modulation Trim not affecting the signal output in Test #4, check the middle, wiper terminal of the trim (also the end of R27 which connects with the wiper terminal) for a DC voltage which varies from negative 12VDC to positive 12VDC as the disc is adjusted from one extreme to the other.

This variable voltage should work to minimize the signal level at the VCA A output. It might not be eliminated, particularly if you are going into a sensitive input, but there should be a significant difference between the levels heard at the extremes and the dip which occurs at an intermediate setting of the trim corresponding to a VCA ADSR “off” control into the VCA A section. Looking at the one in P9700S here, it is set about mid-rotation for this condition.

Test#6 has you checking for a complex tone which results from using one audio signal to modulate another audio signal. The difference you notice in the “mix” of the signals can be the result of something awry in Test#4, but it also is affected by the Carrier Trim setting which is set in the Calibration section on page 22 of the manual (advanced about two-thirds of the way on the unit here). DC voltage testing can be made for this trim, R34, in the previously described Modulation Trim tests.

If this checks to be OK, below are some other DCV readings in the VCA A section going sort of left to right from IC6c to IC6D according to the schematic. Set ADSR controls to 9:00 and modulator to Cycle.

IC6pin9 0V
IC6pin10 0V
IC6pin8 4.9

R34 wiper terminal (appx. calibrated setting) 4.4V

IC4pin10	5v
IC4pin8	5v
IC4pin2	-0.73
IC4pin3	-0.74 to -0.91
IC4pin1	-0.01 to -0.02
IC4pin4	-0.02 to -0.20
IC4pin14	-12
IC4pin5	-10.47
IC4pin6	6.33 to 6.35
IC4pin12	6.35 to 6.37

IC6pin13	4.75 to 4.90
IC6pin12	5.35 to 5.37
IC6pin14	-0.04 to 0.23
