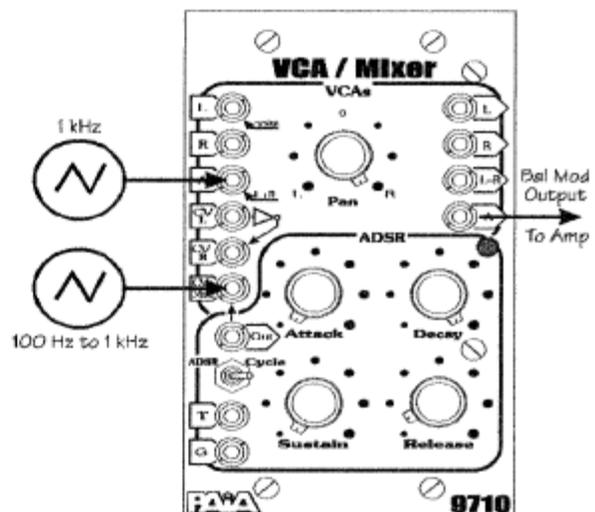
VCA section from 9710 illustration supplement, fig 7, schematic

“In step #4 there was a slight tone with the Pan control at full "R"; when turning the "Modulation Null Trimmer" there was no discernible difference in the tone.

In step #6 there was a modulation sound, but the carriers were not of the same volume. The original carrier was much more dominant than the modulating signal.

A problem here most likely involves IC4, Q3, Q4 or associated parts. IC6 might be a problem, but sections of it are working OK in the VCAs so the chip is most likely good. Check front panel wiring involving J3 and J6. If you don't find anything, continue to the next test which may help localize the difficulties.

If this is not working and there was also a problem in step 4 the culprit may be IC4 or the parts associated with it. The Carrier input buffer IC6:C or the differential output buffer IC6:D may not be working.

If step 4 was OK but there's a problem here in step 6 there is probably something wrong with the way J6 is wired.

The “trouble” checks following each Testing section are only very general. For example, for Test #4 check IC4, Q3, Q4 or associated parts, and, IC6 and Js 3 and 6 wiring – this simply implies verifying the parts are the ones specified and with the proper polarity, good soldering, etc. It is rare for parts to be the trouble due to defects, though they can fail if an accidental short-circuit occurs (ie board soldering comes in contact with metal while powered or probing for voltages results in contact between two nearby but separate circuits).

This variable voltage should work to minimize the signal level at the VCA A output. It might not be eliminated, particularly if you are going into a sensitive input, but there should be a significant difference between the levels heard at the extremes and the dip which occurs at an intermediate setting of the trim corresponding to a VCA ADSR “off” control into the VCA A section. Looking at the one in P9700S here, it is set about mid-rotation for this condition.
