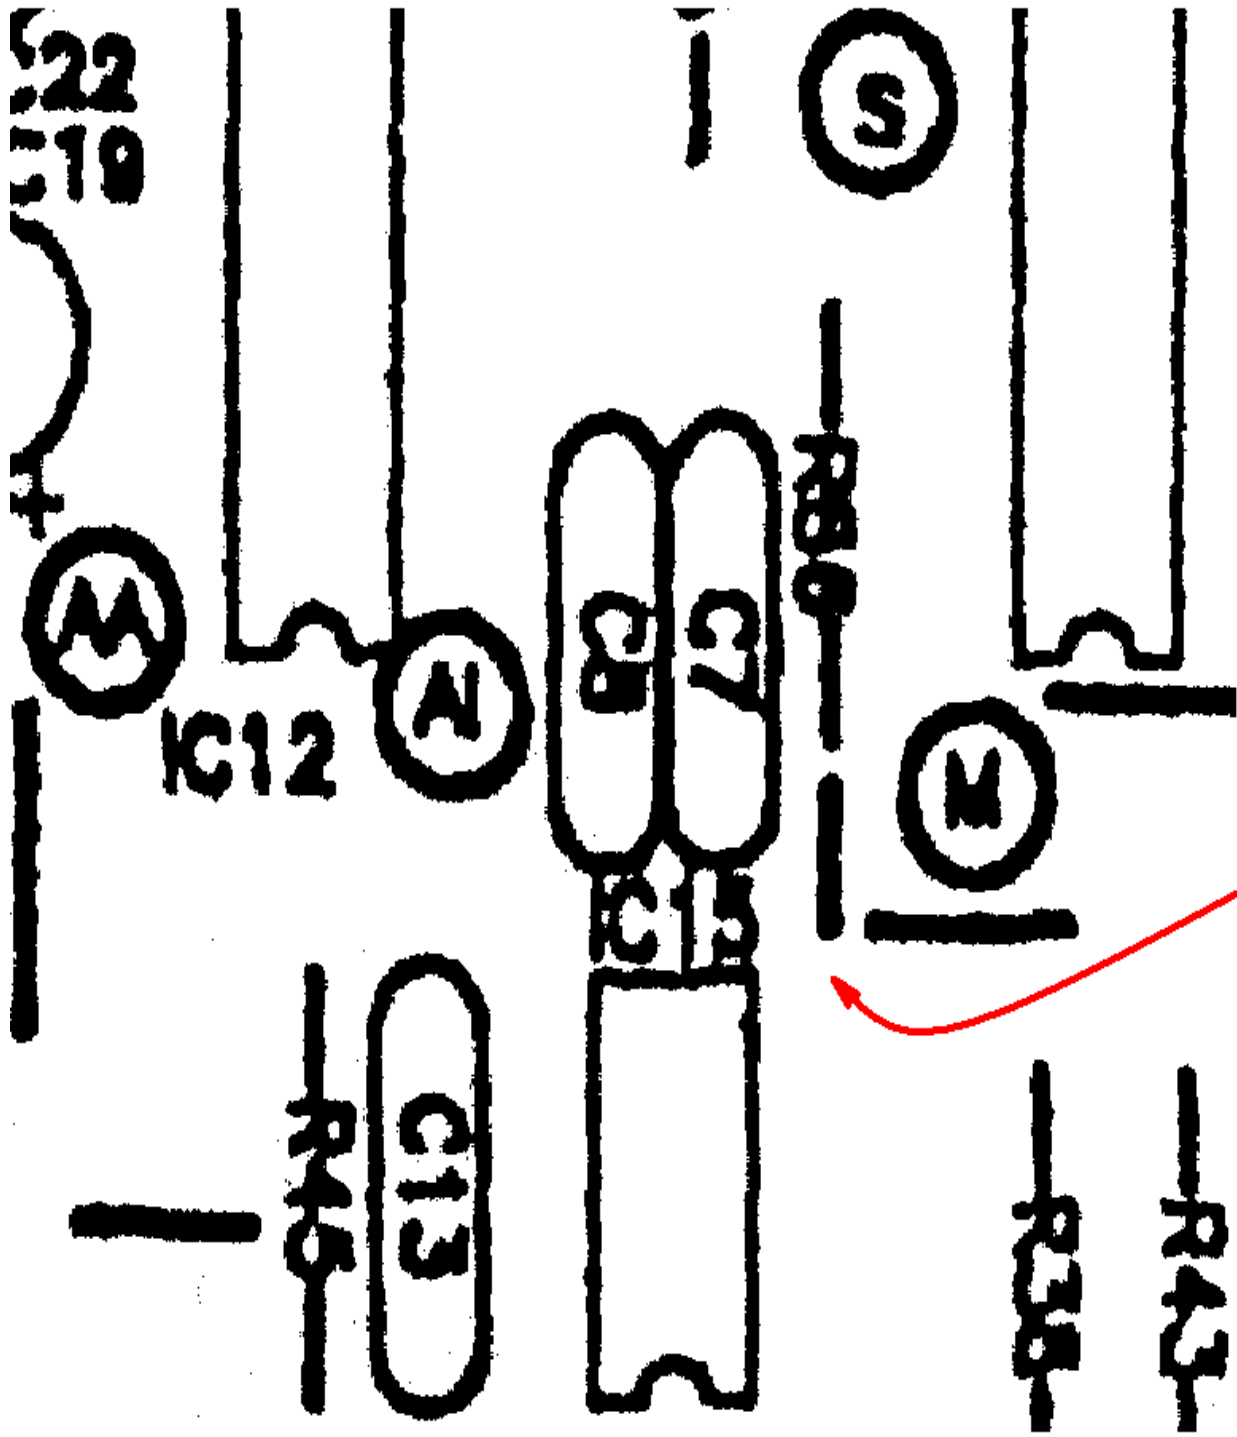
Check that this jumper wire is in place and inspect the solders for evidence the excess wire extending through the joints was clipped. It is just a shallow, smooth dome of solder, there might not be wire in the joint. If there is extra on the top side, melt the joint while pushing the wire into it. It might just be necessary to replace the length of wire used for this jumper. Look too for signs of the solder pad for the jumper having detached from the connecting trace.
